## Sandstone Bridge Deck Dalton, Lancashire

### Case Study

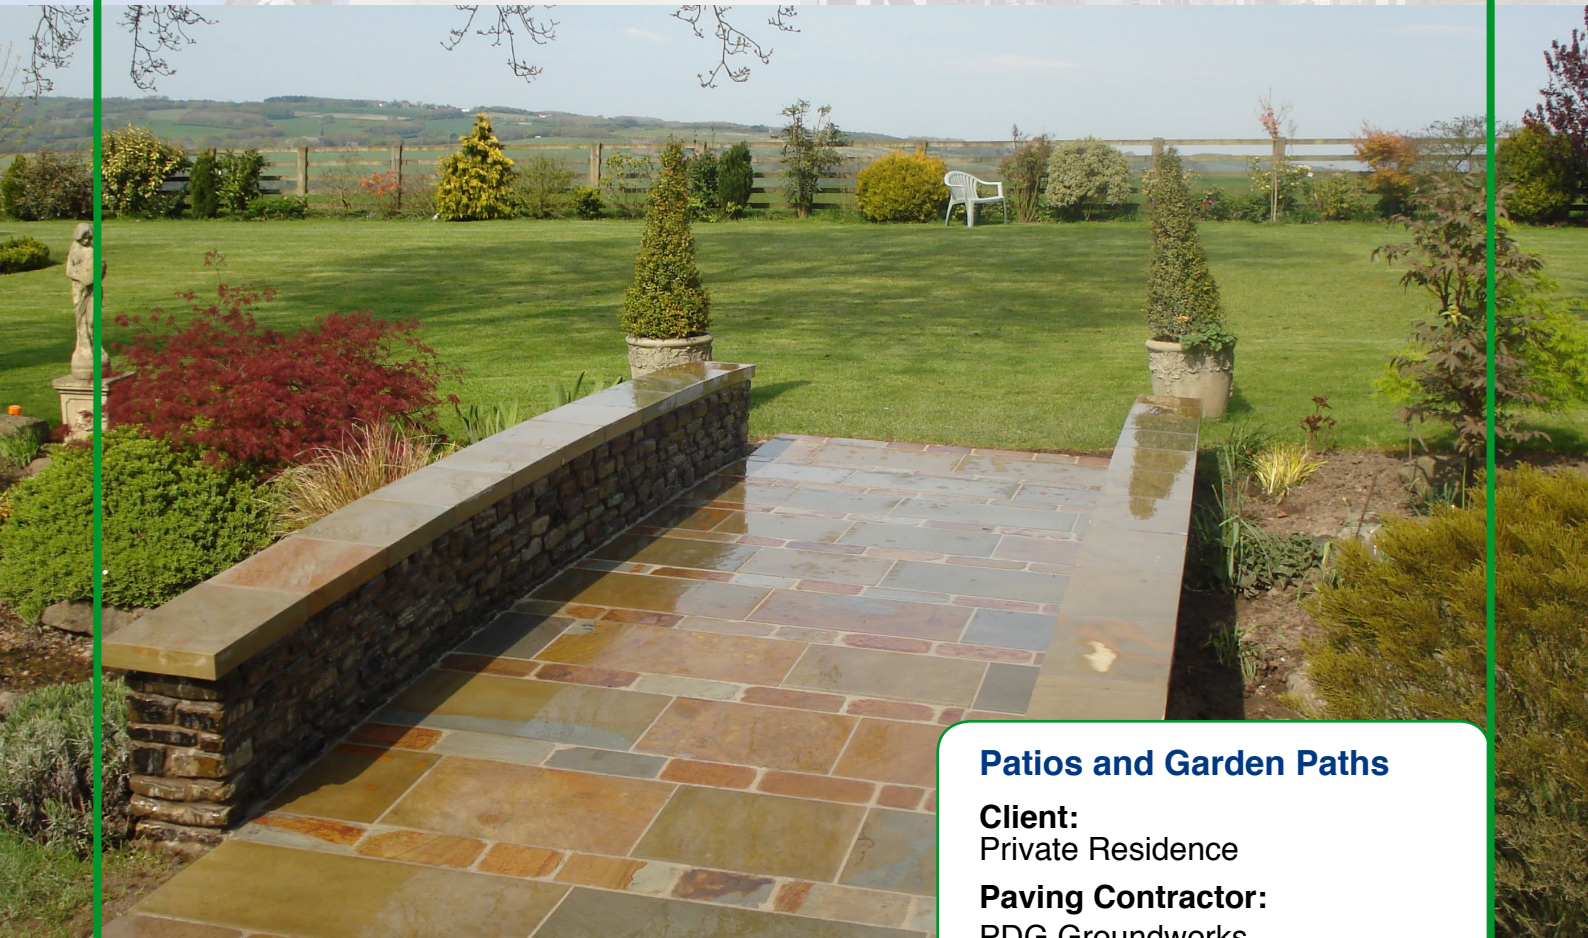
The old existing timber deck on this concrete bridge deck was removed due to it continually becoming slippery and dangerous to walk across. The natural stone contractor PDG Groundworks, were contracted to lay a new textured, natural stone pathway, including a high performance jointing mortar, so that any excess water could safely run off the surfaces to falls, especially during the wet winter months, without becoming dangerous.

The owner selected 450mm wide x 50mm thick, six-side-sawn sandstone paving slabs in random lengths, with additional flame texturing of the surface, which were then securely bedded by PDG using **GftK's vdw 850 Paving Joint Mortar** for all of the joint pointing and grouting works. From extensive experience they knew that this was the best solution to providing the high performance and durability required.

**GftK's vdw 850 Paving Joint Mortar** from **NCC Streetscape Limited** is a high performance, epoxy resin bound sand grout that is applied as a 'wet-slurry', which self-compacts into the joints to give a non-staining and highly durable finish, designed to last for many years to come.
