Terrace - Listed Building, Macclesfield

Case Study

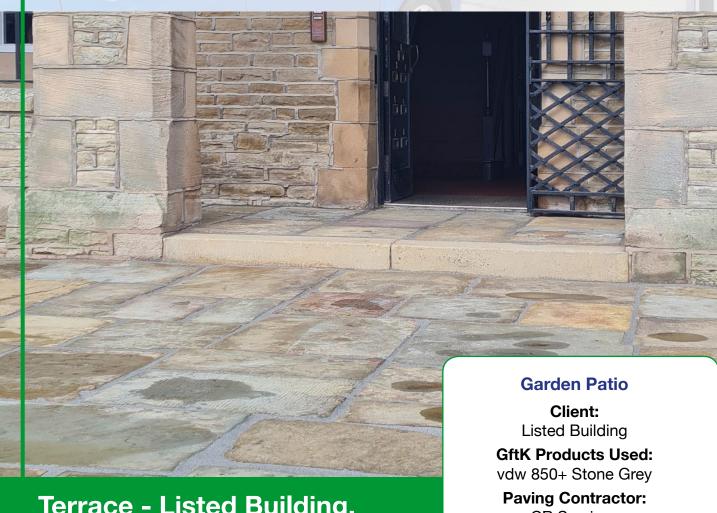
The predominantly Yorkstone paved terrace of this beautiful, listed building in Macclesfield was in desperate need of refurbishment, with cracked and failing jointing mortar, stained slab surfaces, and an abundance of green growth on the slabs and in the joints, as well as an extensive amount of difficult to remove, lichen 'black spots' in the pores below.

GftK's vdw 850+ epoxy resin based, paving joint mortar from NCC Streetscape was the ideal choice to durably repoint the failed joints, especially as they had various widths and depths, as is typical with historic Yorkstone paving, and which always leads to problems of shrinkage and cracking with traditional cement-based pointing.

After remedial works to remove the old jointing, the paving was jet-washed and then the surfaces treated with NCC Black Spot and Green Growth Remover, again supplied by NCC Streetscape, which does it exactly what it says on the tin!

The non-staining, vdw 850+ is wet slurry applied by squeegee, and it effectively self-compacts into the joints, enabling CR Services to complete the job in double quick time, with the terrace now looking as good as, if not better than new.
