Patio and Terrace - Private Residence, Skelmersdale

Case Study

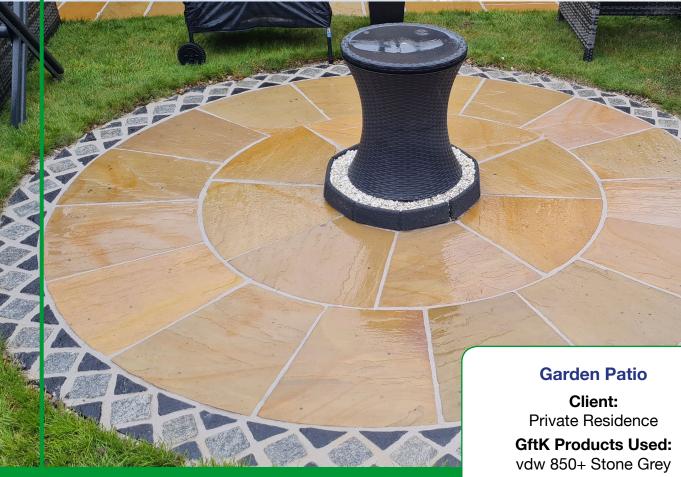
This refurbishment project at a private residence in Skelmersdale, Lancashire, comprised of natural sandstone patios and pathways, plus a once attractive, bespoke designer sandstone circle, complete with granite sett edging, all of which were now looking sad and dirty, with cracked and failing joints throughout. The owners contacted patio refurbishment specialists CR Services who they found on Facebook, and who had completed several similar projects around Manchester. Immediately it was clear that NCC Blackspot & Green Growth Remover, plus GftK's vdw 850+, a non-staining, 2-part epoxy resin based, paving jointing mortar, were the ideal solutions.

The paving was jet-washed, then the old jointing removed and surfaces treated with the NCC Blackspot & Green Growth Remover, to facilitate the removal of unsightly growths and dark staining deposits from the natural stone slabs.

Although it was raining at the time booked for the job, this was no problem using GftK's vdw 850+, as it is applied by wet-slurry techniques, meaning that during application the wetter, the better! The material effectively self-compacts into the joints, without additional tooling, and then hardens, even if the wet weather continues!
