Sandstone Patio Stalybridge, Greater Manchester

Case Study

Pavement Jointing Mortars

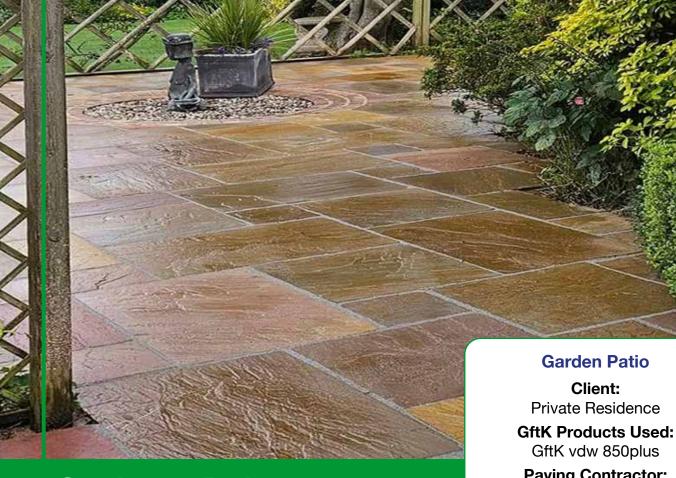
The large, natural sandstone patio and pathways at this private residence in Stalybridge, was badly in need of refurbishment. It had become extremely dirty and unsightly, the jointing mortar was cracked and failing, plus some slabs were broken and needed replacing. Also there were extensive, difficult to remove, lichen 'black spots' in the surface pores of the slabs. The homeowners 'pride and joy' was completely spoilt.

Specialist paving contractor, CR Services, removed the old jointing and rebedded any loose slabs. Then they jet-washed the whole area and treated the surfaces with NCC Black Spot and Green Growth Remover, and the area re-pointed with GftK's vdw 850plus, all completed in very quick time, despite the mostly cold and wet weather.

The completly refurbished patio is now as good as new, in fact it is better, as they can now regularly jet wash their patio clean, without fear of damage to the pointing.
