Case Study

Cleaning & Sealing Natural Sandstone Patios & Pathways in Stoke Mandeville, Bucks

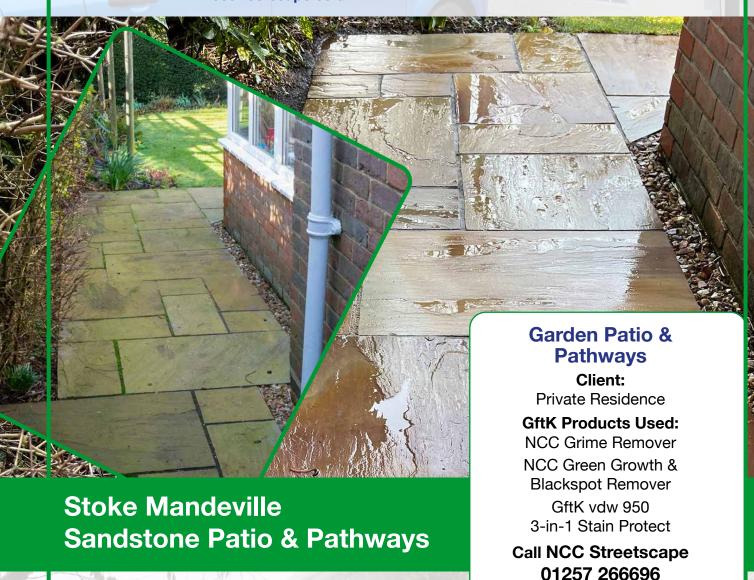
After the recent poor summers and long, wet winters, some of the areas had become unsightly with a build-up of dirt, grime and green growth, as well as 'blackspots' from lichens accumulated in the surface pores.

Therefore, the homeowner contacted NCC Streetscape again, as they had previously advised thorough surface cleaning to be carried out prior to repointing with GftK paving jointing, but at that time the owner could only refurbish and repoint the area for safety at a family function. NCC recommended initial jet washing and cleaning with NCC Grime Remover, a powerful and highly effective general cleaner, followed by NCC Black Spot and Green Growth Remover. This was left overnight to penetrate deeply and work to remove residual green growths and the dark 'blackspots', then the surfaces were finally jet-washed to restore the original colours of the natural sandstone.

With the paving clean and looking good again, it was allowed to dry for a few days, then the surfaces was sealed by impregnation with GftK vdw 950 3-in-1 Stain Protect, a unique impregnating paving sealer, surface protection and stain resistant treatment. This will greatly assist in keeping the paving in good condition and making future cleaning much easier.
