Riven Sandstone Patio & Terraces, Glossop, Derbyshire

Case Study

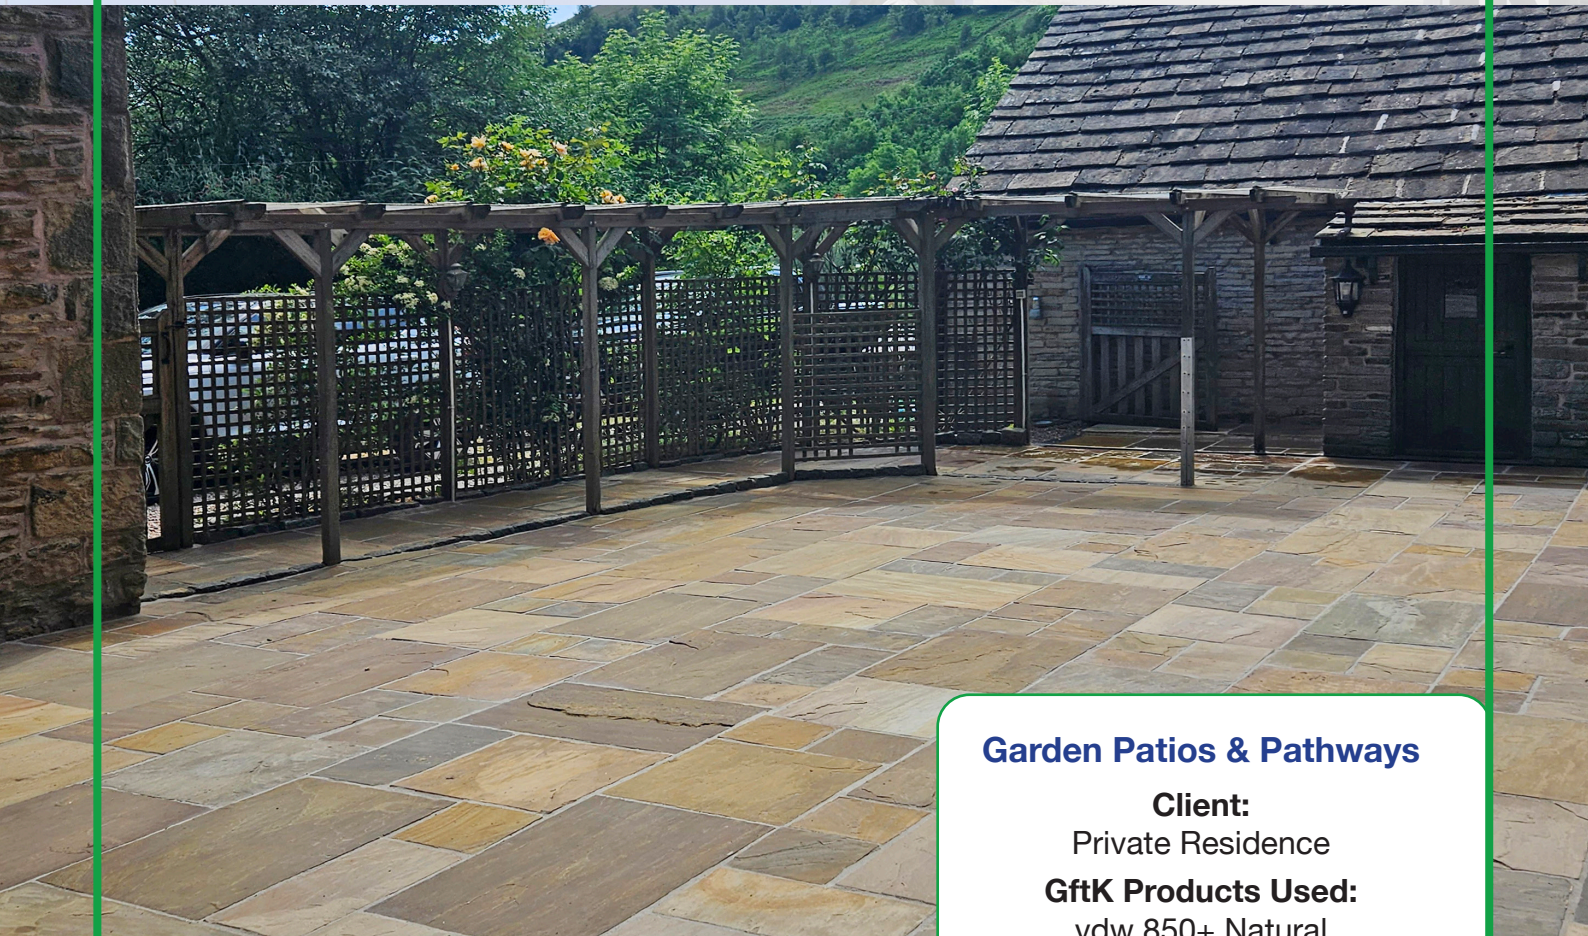
This charming old cottage, in Glossop, the High Peak district of Derbyshire, has 170m² of traditional old riven sandstone paving, up to 70mm thick, not unlike Yorkstone. Some areas are also used as hard standing for motor vehicles. The paving had been down for many years, and was in an extremely tired condition, with some missing slabs, old cracked and failing cement based joint repairs, together with dirt, grime, moss and lichen build up on the surfaces.

After online research, the homeowners contacted specialist paving contractor, CR Services, who together with their materials supplier, NCC Streetscape, recommended replacing the failed jointing with GftK's vdw 850+, a professional, high performance, 2-part paving joint mortar, which is applied by wet slurry techniques from a standing position, making the process fast and efficient. It can also be applied in wet and cold conditions, meaning far less delays because of the weather.

Prior to grouting, missing slabs were replaced, loose slabs were reset, and the area was jet-washed and cleaned, using NCC Black Spot & Green Growth Remover, which removed dirt, grime and unsightly green stains, plus hard to remove black lichen spots.
