Porcelain Patio Refurbishment, Croston, Lancashire

Case Study

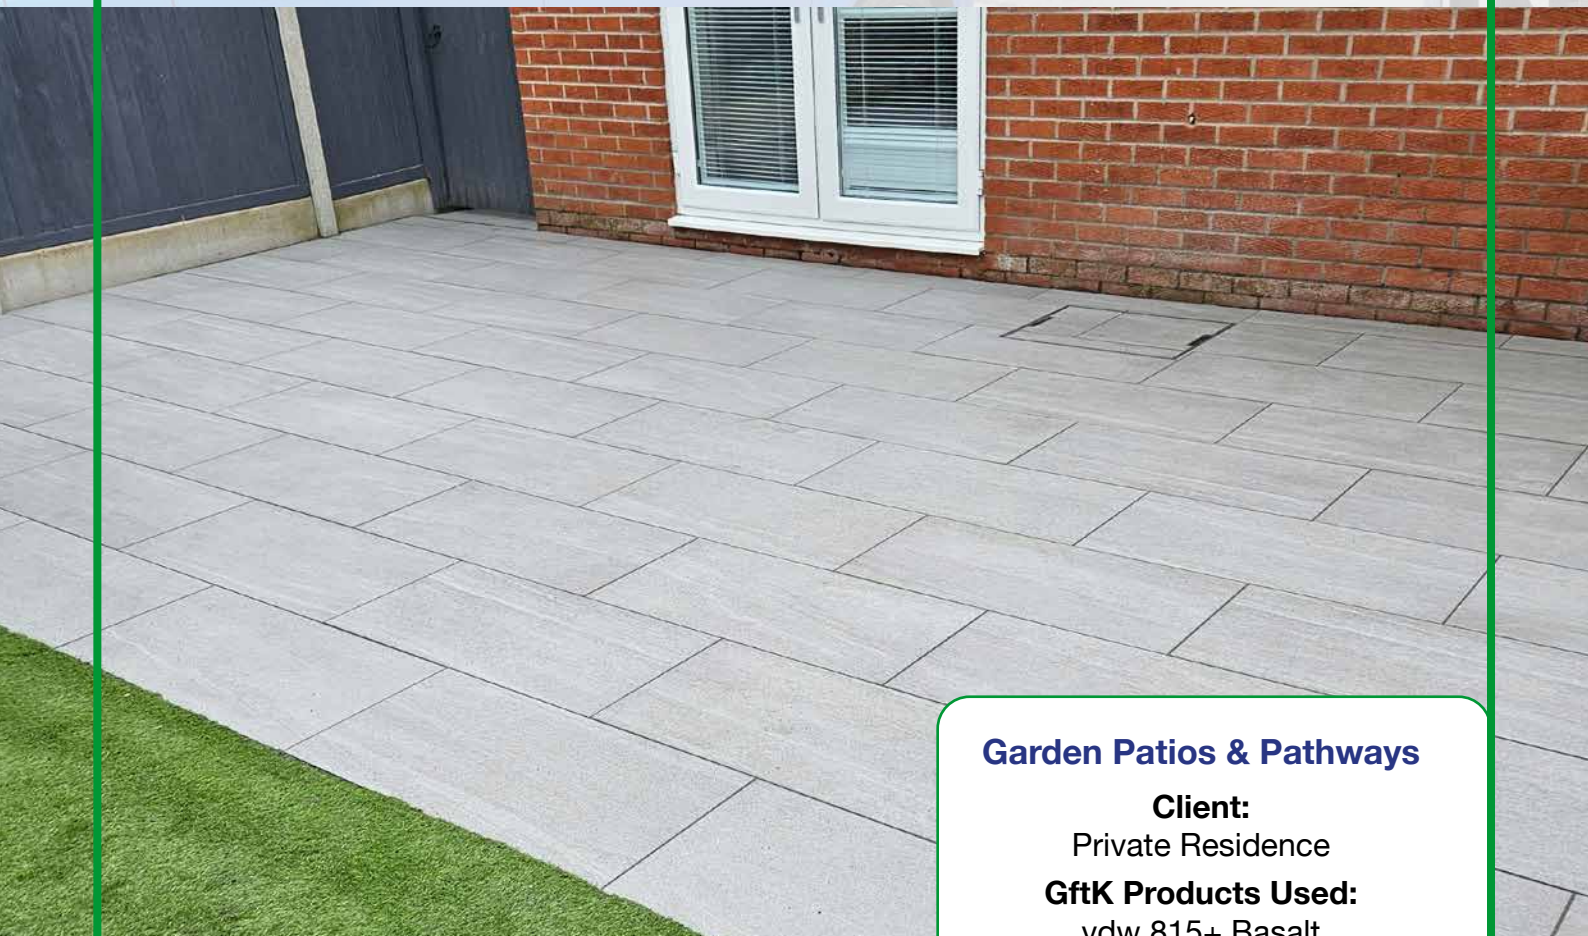
The owners of this property, in the picturesque village of Croston, in Lancashire, were desperate to find a solution to the problems they were encountering with their porcelain patio. It had only been down for two years and the pointing had already failed and been repointed twice, yet it was coming out again.

All the existing failed residual jointing compound was removed and replaced with GftK vdw 815+, a 2-part, high performance, epoxy paving mortar, that is stain free, self compacts into the joints, and is fast and efficient to wet slurry apply. It is specifically designed for narrow joints, and importantly, can be safely jet-washed for ease of future maintenance.

The patio area was cleaned with NCC Porcelain Aftercare cleaner to give an 'as new' look to the area, which the owners said was far better than when originally built and they were delighted to now be able to keep their patio looking this way in future.
