Porcelain Patio Refurbishment, Bury, Lancashire

Case Study

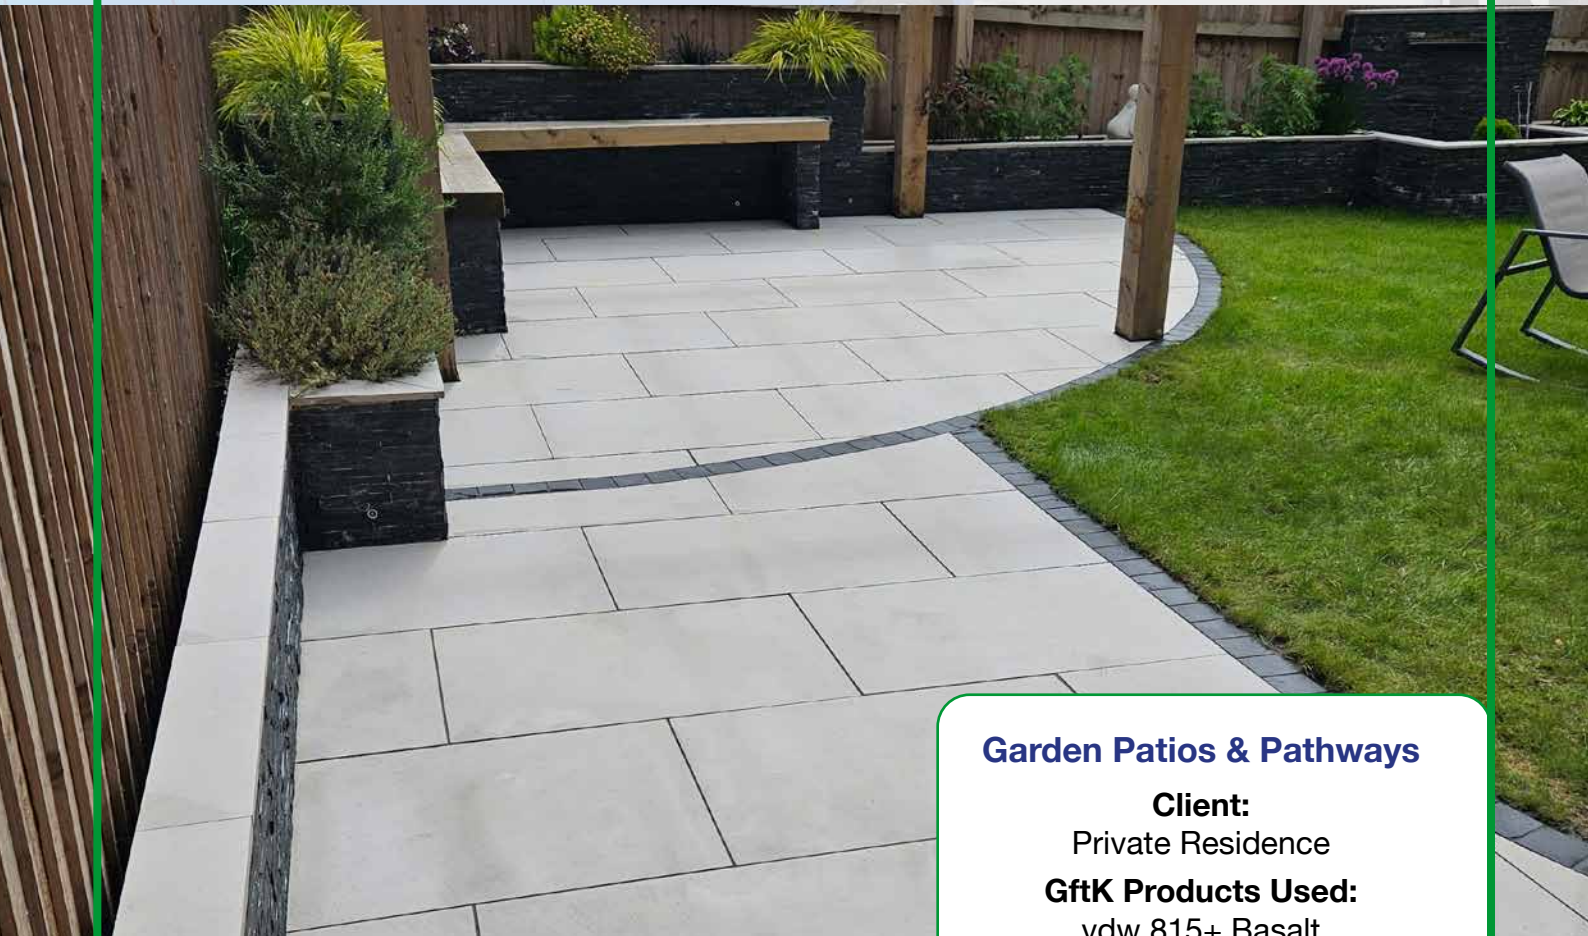
The owners of this private residence in Bury were disappointed that their beautiful porcelain patio had become unsightly. Although less than a year old, the original pointing on their white porcelain patio, with dark grey Brazilian slate sett edging, was already failing and coming out. Also the jointing compound used for the pointing had left unsightly staining to the edge of the tiles, giving an unwanted 'picture frame' effect.

Online research led them to contact CR Services, who together with their professional material suppliers, NCC Streetscape, knew exactly what to do to remedy the situation! Firstly, all failed jointing was removed and the porcelain slabs were then cleaned with NCC Porcelain Intensive Cleaner, which removed the staining from around the tile edges.

The porcelain patio was then repointed with GftK's vdw 815+, a tough, 2-part, high performance, non-staining, paving joint mortar, especially designed to give high performance in narrow joints. It is applied standing up by the wet slurry method, effectively self-compacting into the joints, so no finishing tooling required!
