Patio and Pathways, Bury, Lancashire

Case Study

Garden Patios & Pathways

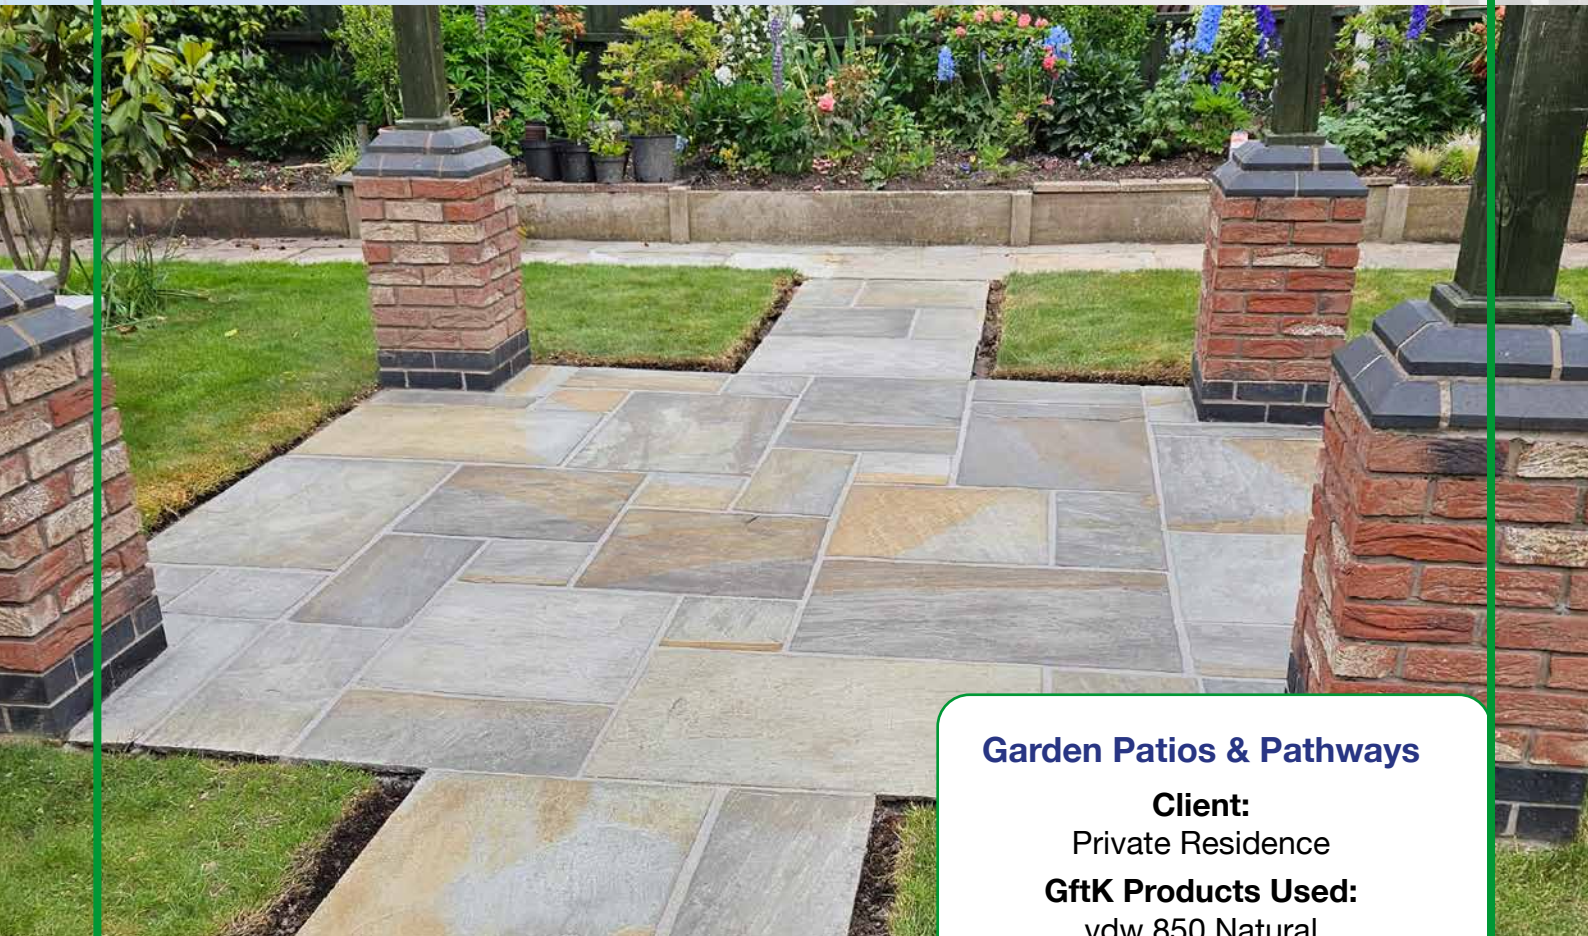
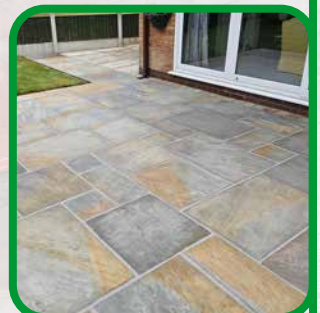
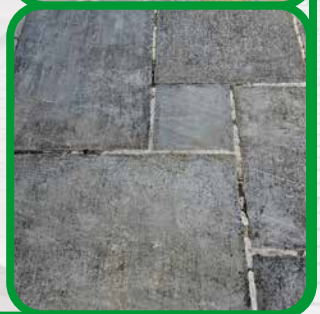
This large refurbishment project in Warrington comprised of a traditional sandstone patio, plus pathways, and an ornamental brick and wood built gazebo area. Only seven years old, these once attractive paved areas had now become unsightly because of cracked and failing sand and cement pointing mortar, together with a build-up of dirt, grime, moss and lichen spots on the surfaces.

Specialist paving contractors, CR Services, in consultation with their material suppliers, NCC Streetscape, worked out a plan of action for the homeowners. Having been given the go-ahead, they cut out the failing mortar, jet-washed all surfaces and then applied NCC Black Spot & Green Growth Remover to clean up and remove the unsightly growths and dark staining deposits that had accumulated on the natural stone slabs.

All areas were then repointed with GftK vdw 850+. This is an extremely durable, 2-part epoxy based jointing mortar, that effectively self compacts into the joints without tooling, and is applied by wet-slurry techniques from a standing position, so is quick and efficient.
