Case Study

Pavement Jointing Mortars

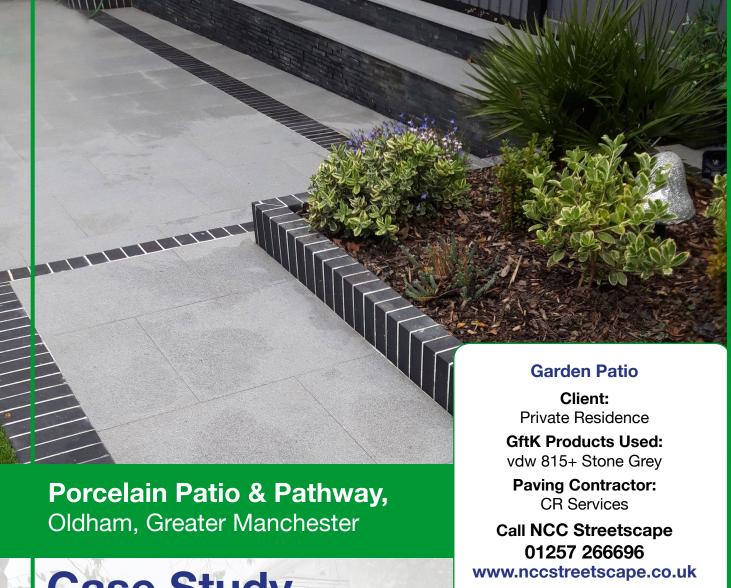
This beautiful porcelain patio in Oldham had only been down for 12 months, but already the paving joint compound (single-pack) used for the original job was failing. The narrow joints between the porcelain slabs are not condusive to standard jointing mortars, and a product designed for porcelain and narrow joints is essential to obtain a tough, long lasting result.

CR Servces removed the failing joint compound and replaced it with vdw 815+, which is easily applied as a wet slurrry, thus leaving no voids to weaken the integrity of the narrow joints. All the work is carried out from a standing position and can be applied in inclement weather which is a big advantage and ensured that the job was carried out quickly and efficiently.
