Sandstone Patio and Terraces, Cheshire

Case Study

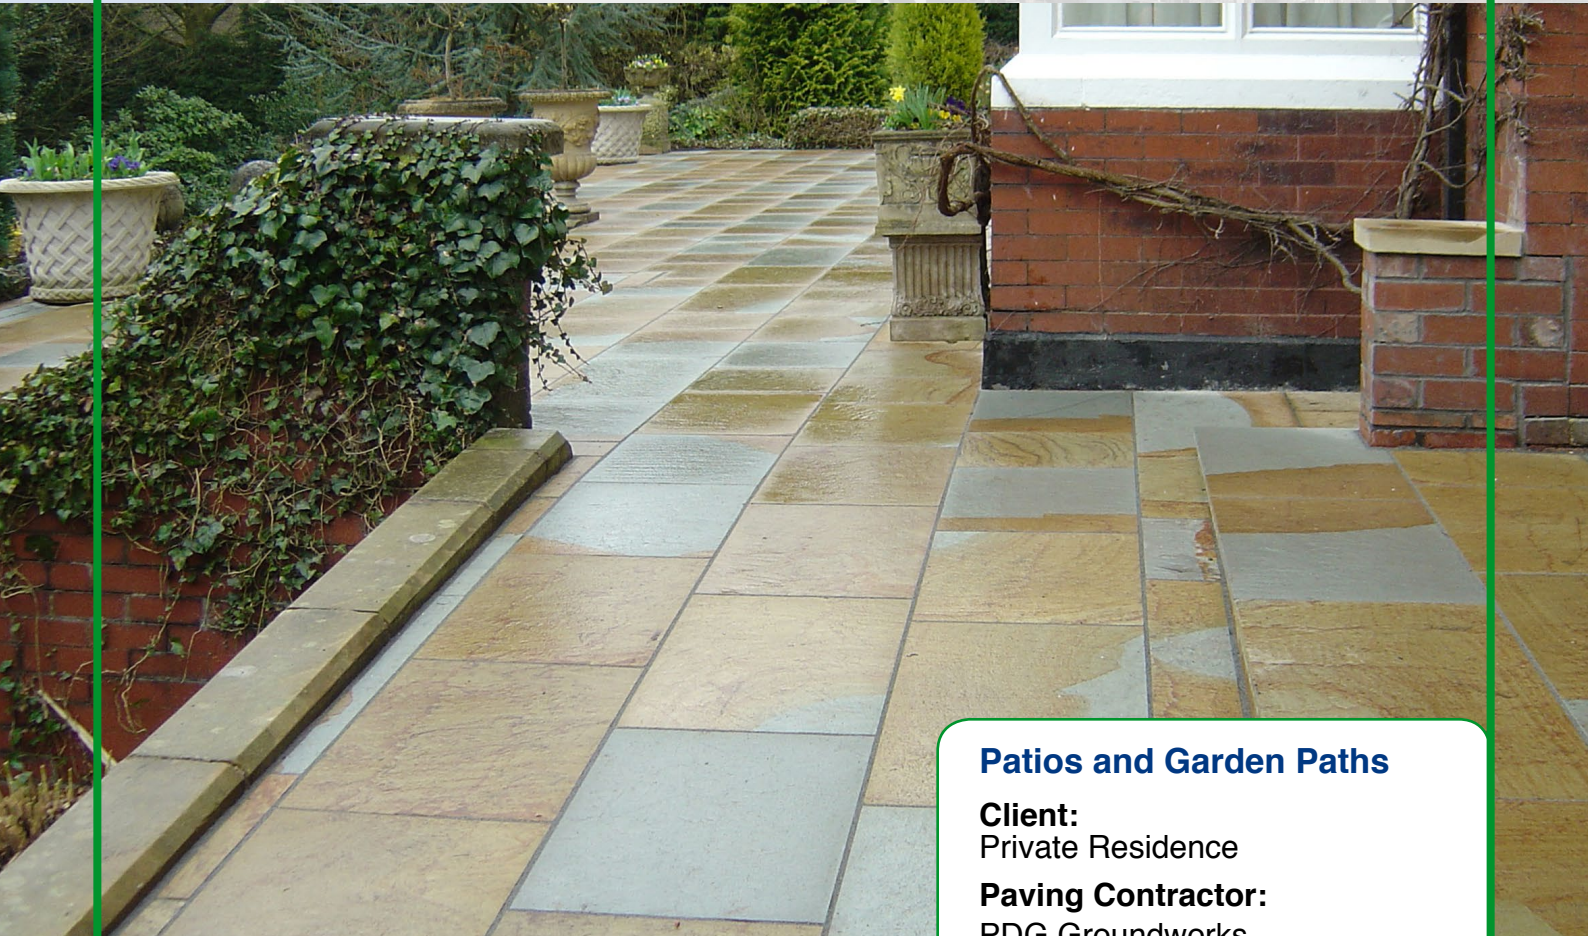
This new patio was created with 450 wide x 30mm thick, random length, sandstone paving slabs, with a flame textured finish. To prevent any premature failure of the pointing material, **GftK's vdw 800 Paving Joint Mortar** was used to grout and point all of the joints in a 'Basalt' colour. The **GftK vdw 800** series of paving jointing mortars from **NCC Streetscape Limited** are now the 'Standard Pointing' materials used by PDG for all natural stone paving projects.

Existing deteriorated concrete paving slabs were lifted and removed, due to their heavy discolouration and edge damage, caused as a result of the proprietary sand and cement based pointing cracking and breaking-up, a common problem with all cement based paving pointing materials, as is staining as well of course.

These advanced **GftK** jointing materials were selected after extensive evaluations, because they are fast and reliable to install on pre-dampened paving surfaces as a 'wet-slurry', which then actually self-compacts into the joints, plus they do not stain sandstone and other sensitive stone surfaces. Additionally as they are wet slurry applied, there is no waiting for dry weather and the pointing can always continue to help ensure that projects are finished on time and on budget.
