Large Sandstone Patio, **Northwich**

Case Study

Pavement Jointing Mortars

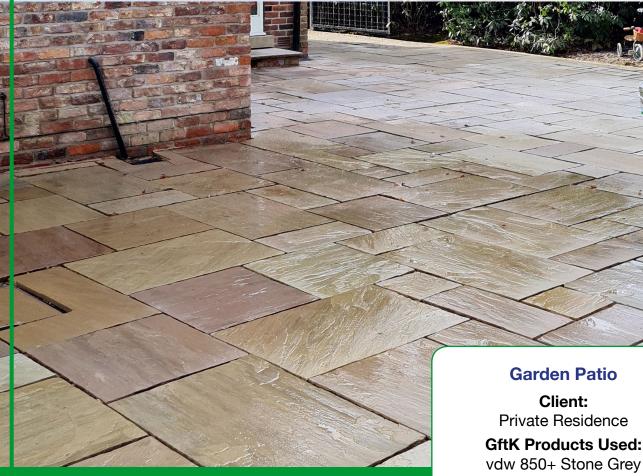
The large, very dirty sandstone patio and cobbled area at this private residence in Northwich was badly in need of refurbishment. The jointing mortar was cracked and failing and there was an extensive amount of difficult to remove, lichen 'black spots' in the surface pores of the slabs, completely spoiling the appearance of this once attractive area.

GftK's vdw 850+ is a tough, non-staining, 2-part epoxy paving mortar, supplied in the UK by NCC Streetscape, which was recommended by specialist contractor CR Services as the ideal solution for this large project, with the patio covering more than 235m².

After remedial works to remove the old jointing, the paving was jet-washed and then the surfaces treated with NCC Black Spot and Green Growth Remover, which brought the natural stone back to its original beauty.

Although it was raining at the time booked for the job, this was no problem when using GftK's vdw 850+, as it is applied by wet-slurry techniques from a standing position. meaning that during application, the wetter, the better! The material effectively self-compacts into the joints, without additional tooling, and then hardens, even if the wet weather continues! In fact, despite the inclement weather, the whole project was completed in a week!
