## Sandstone Patio & Pathways, Alderley Edge

## **Case Study**

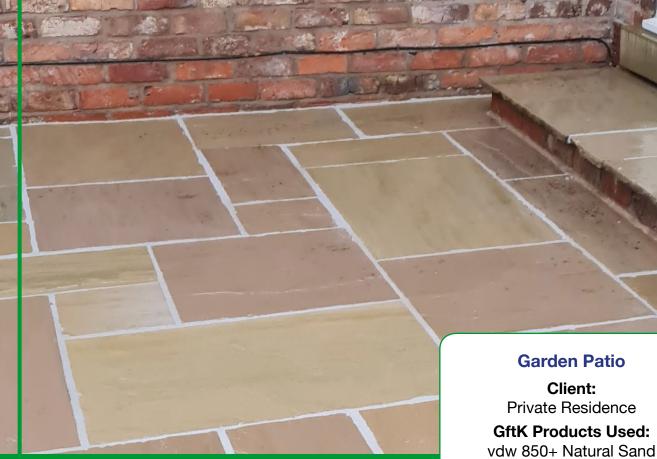
This private residence in Alderley Edge has a large sandstone patio and pathways covering an area of 180m<sup>2</sup>. Over the years these areas had become extremely dirty, with failed, cement based jointing, together with unsightly dark staining deposits on the natural stone slabs. The homeowners decided it was time to give the patio and pathways some care and attention and bring them back to their original beauty. They contacted specialist contractors CR Services who had completed many such projects in the area.

CR Services recommended GftK's vdw 850+, which is a non-staining, 2-part epoxy paving joint mortar, supplied by NCC Streetscape, that is ideal for all types of natural stone paving. It is applied by wet slurry techniques, and will harden even in the cold and wet, so no delays in working due to inclement weather. Additionally it is effectively self-compacting into the joints, with no additional tooling, which makes the application extremely quick and clean.

Prior to grouting, all areas were jet washed, the old failed jointing was raked out and any green growth and black lichen spots were removed using NCC Black Spot and Green Growth Remover, again supplied by NCC Streeetscape.
