Marshall's Limestone Patio, Bollton, Lancashire

Case Study

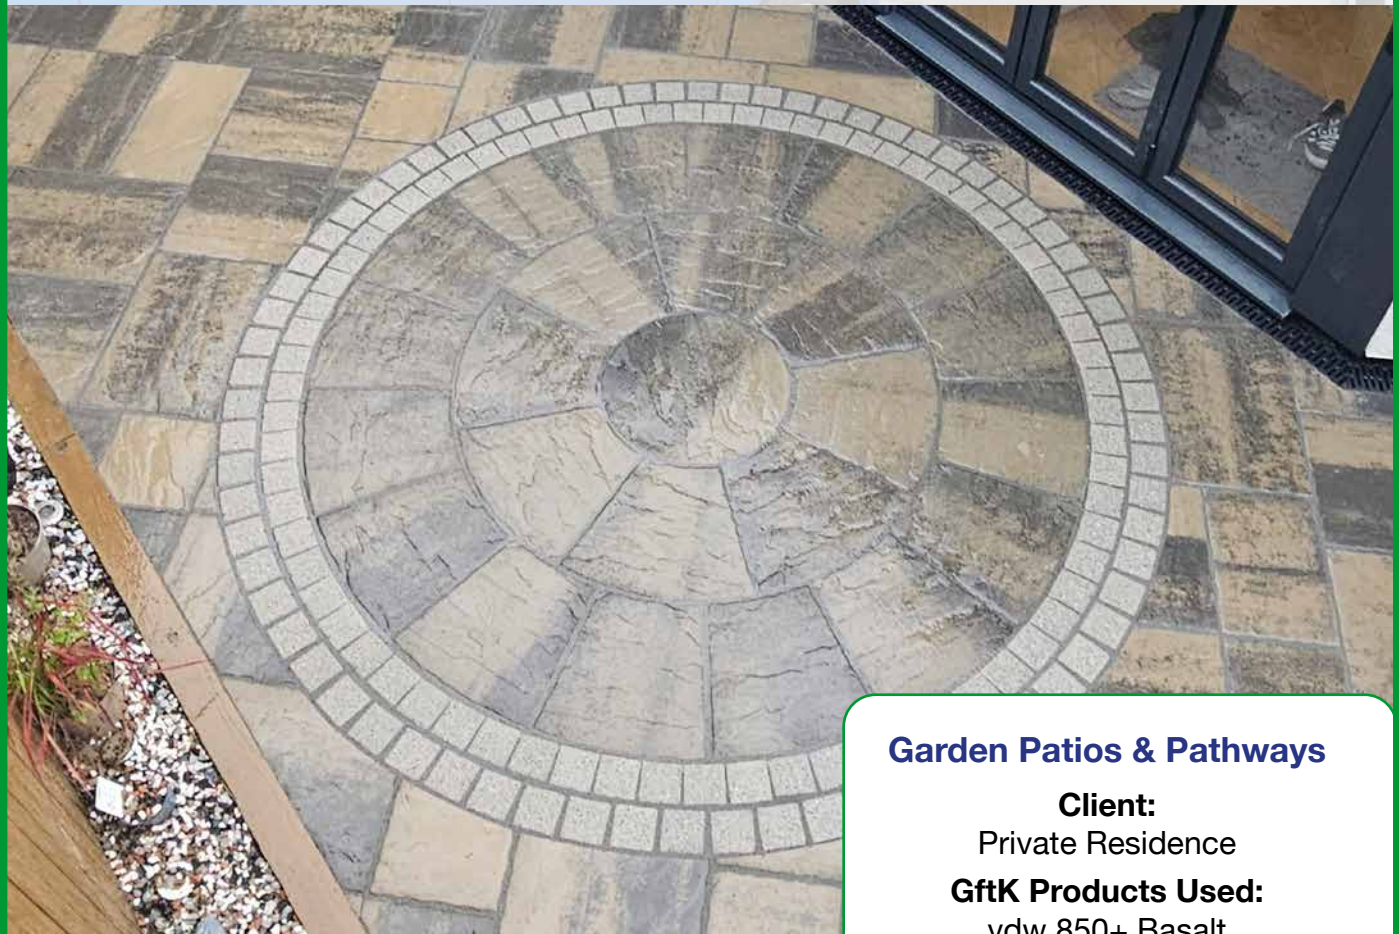
This bespoke stone circle and patio area at a private residence in Bolton, Lancashire, was laid using Marshall's limestone slabs and granite setts. It was only five years old and generally in good condition, but the pointing had already failed twice. The homeowners liked to keep their patio area in pristine condition, and used their jet-washer to keep it clean. Unfortunately the 1-part jointing compound that had been used was not tough enough to withstand frequent direct jet-washing.

Specialist paving contractor CR Services jet-washed the area and all the old pointing was removed. It was then cleaned using NCC Black Spot and Green Growth Remover. This was followed by repointing with GftK's vdw 850+, which is a high performance, non-staining, 2-part epoxy paving joint mortar, supplied in the UK by NCC Streetscape. It is ideal for natural stone paving and is applied by wet slurry techniques, from a standing position, and can be applied even in the cold and wet, which is ideal with the unpredictability of the UK weather. Importantly for the homeowners, GftK's vdw 850+ will fully resist regular jet-washing.
