Patio & Pathways, Nantwich, Cheshire

Case Study

Garden Patios & Pathways

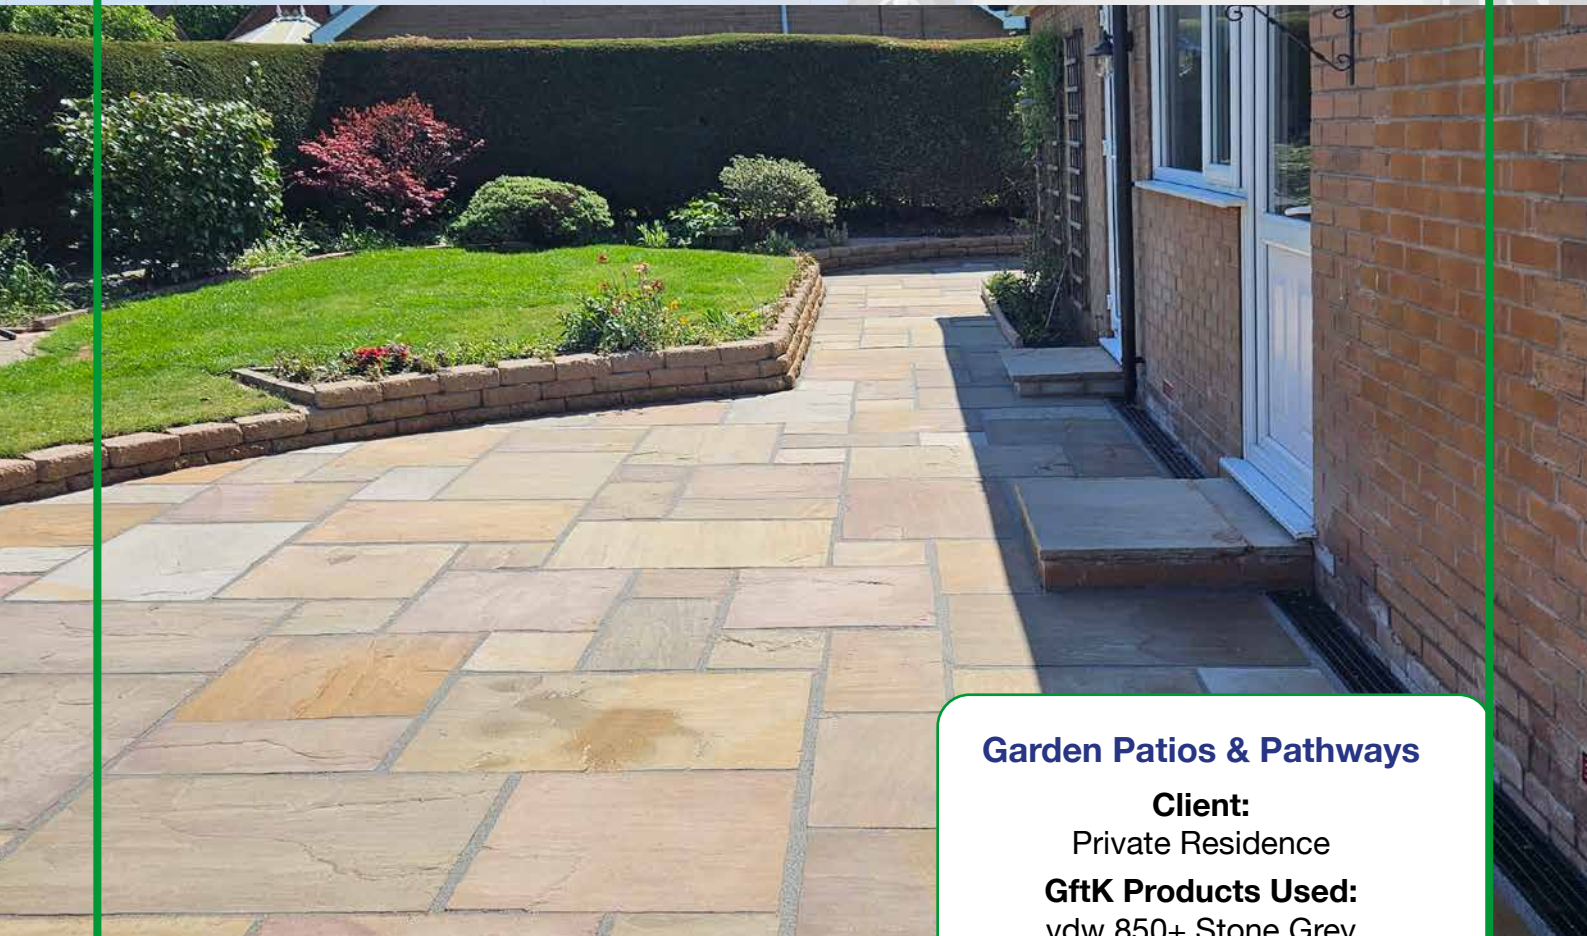
The patio and pathways at this private residence in Nantwich, Cheshire, were 10 years old and badly in need of refurbishment. The original sand and cement jointing was cracked and failing, and the paving slabs were discoloured, with a few slabs debonded. An earlier attempt to repoint the failed joints with more sand and cement had been unsuccessful, and as a result, the paving was unsightly and spoiling an otherwise well maintained garden.

Specialist paving contractor CR Services were contacted and asked to carry out the refurbishment. They first removed the old jointing and reset loose paving slabs, then jet-washed and thoroughly cleaned with NCC Grime Remover, a heavy duty surface cleaner. They then advised using GftK vdw 850+ paving joint mortar from NCC Streetscape as the best solution to replace the cement based pointing.

GftK's vdw 850+ is a tough, high performance, non-staining, 2-part epoxy paving mortar, that effectively self-compacts into the joints, and is applied standing up by wet slurry techniques, making the whole repointing process both quick and efficient.

The paved areas now look as good as new, and in fact are tougher and now able to withstand any future maintenance including frequent jet-washing.
