Cobbled Driveway, Wilmslow, Cheshire

Case Study

Domestic Driveway

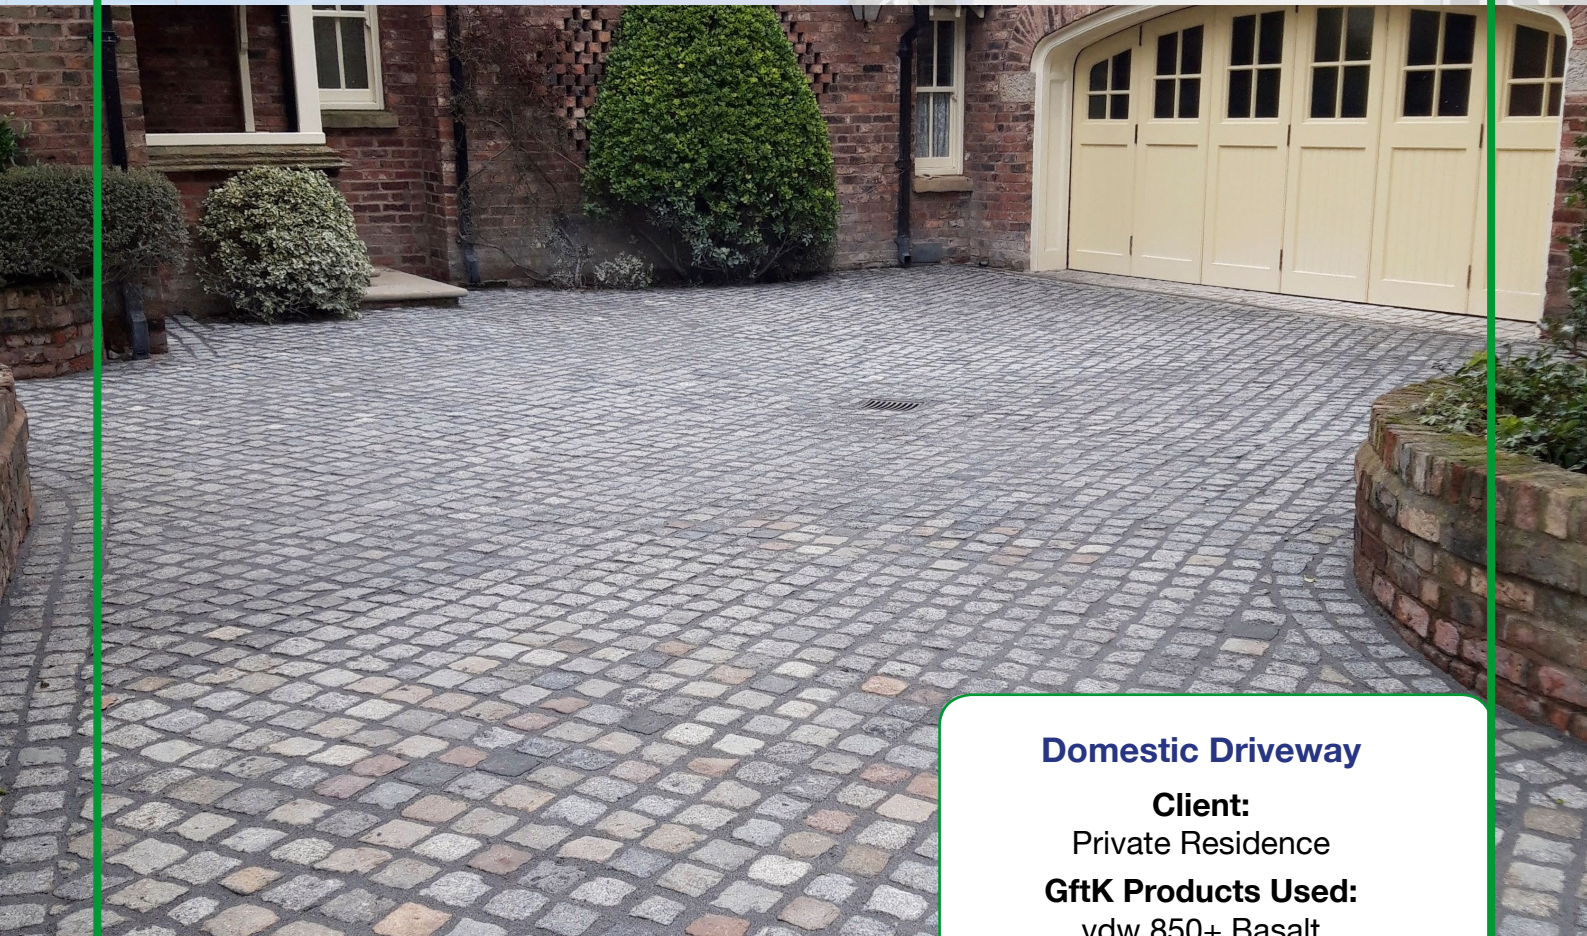
This large cobbled driveway and courtyard, at this residence in Wilmslow, covers an area of 125m², and is subjected to heavy domestic usage as it is driven over daily by the family's three cars. Although the natural sandstone setts were still in good condition, the original cement based pointing was not up to the task with this constant exposure and was cracking and failing.

CR Services removed the failing cement grout and replaced it with vdw 850+, which is applied using wet slurry techniques in a comfortable standing position, effectively self compacting into the joints with no additional tooling, making the whole operation both quick and clean. A major advantage of vdw 850+ is that it can be applied in the wet and cold, so no waiting around for the weather - a huge plus in the UK!
