Royston Footpath

Case Study

Pavement Jointing Mortars

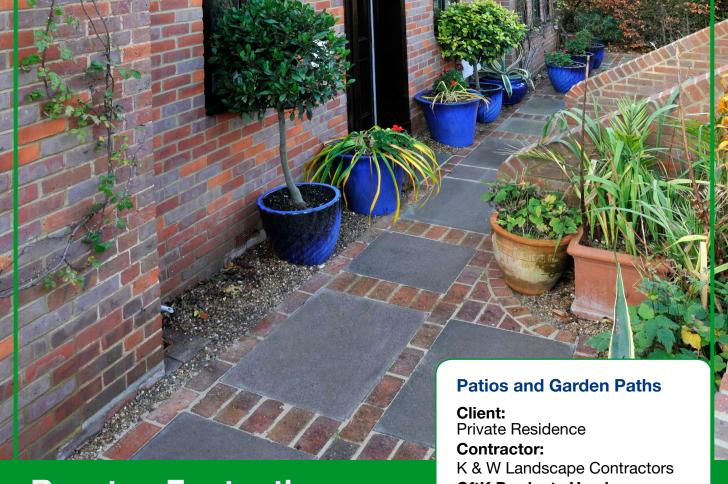
This existing footpath of mixed paving and decorative brickwork was approximately 15 years old and had been repointed at least twice with sand and cement since it was originally laid. The 3-12mm joints had deteriorated again due to weathering and frost action with voids up to 50mm deep.

The landscape contractor solved the problem by repointing with GftK's vdw 800 Paving Jointing Mortar from NCC Streetscape and the whole front of the property's appearance has now been improved dramatically.

This mortar can be applied quickly and efficiently as a self compacting slurry, even in cold or wet conditions – this job was easily completed without weather delays in the cold and wet November 2009. The product was originally designed for jointing natural stone setts subject to vehicular traffic and having a joint depth of minimum 30mm.

However it also provided the best possible solution for foot traffic in accommodating the variable joint widths and depths – not technically correct perhaps, but a practical solution without excessive and expensive cutting out.
